From: Stephen Best
To: Flock Safety Support
Cc: brendon.norton@flocksafety.com; libby.landers@flocksafety.com; Eligio Lara; Daniel Cohen; jake.sherman@flocksafety.com; Michael Balcorta; Stephen Best
Subject: RE: Flock Cameras Still Failing to read...mostly night images... specifically Cameras 086 and 116
Date: Friday, May 17, 2024 6:06:43 AM
Attachments: 052304 Hrs image_2.jpg
001-052304 Hrs.jpg
002-All plates 0519-0524 Hrs.jpg
002-All plates 0519-0524 Hrs.pdf
052304 Hrs image_1.jpg

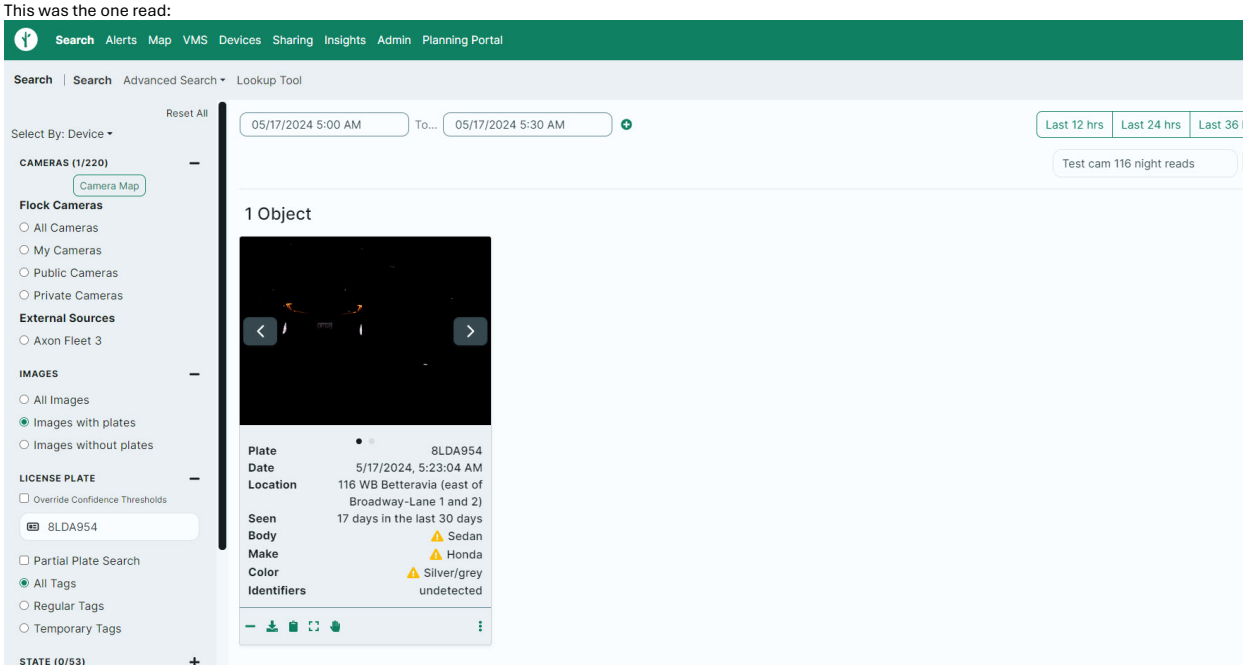
Flock Support (Alex C),
This morning, I drove past Cam "116 WB Betteravia (east of Broadway-Lane 1 and 2)" three times. It only recorded my plate one time. (33% success rate)
I drove past at 05:19:40 in the #2 lane, 05:20:43 in the #2 lane and 05:23:04 in the #1 lane.
This was the one read:

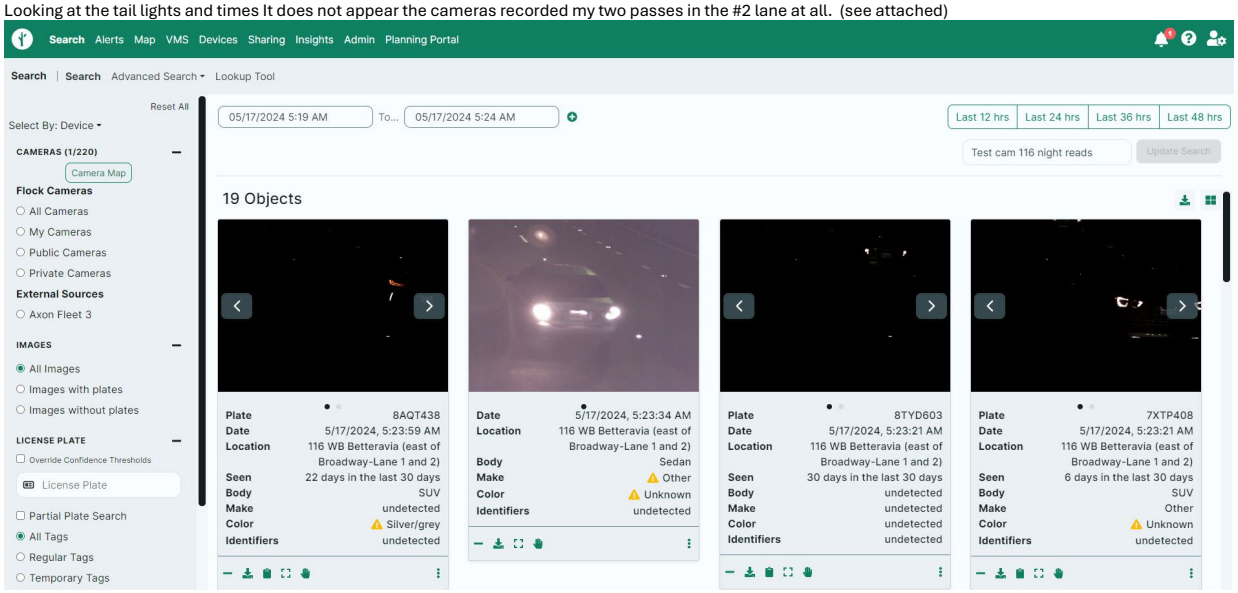
I searched camera 116 for all images, 0519-0524 Hrs. and got 19 objects.
Looking at the tail lights and times It does not appear the cameras recorded my two passes in the #2 lane at all. (see attached)
